Manhole Inspection Summary

Manhole # S3500_051MH

Insp Date: **1/24/07 1:40 PM**

Location Address: **2310 22 1/2 ST**

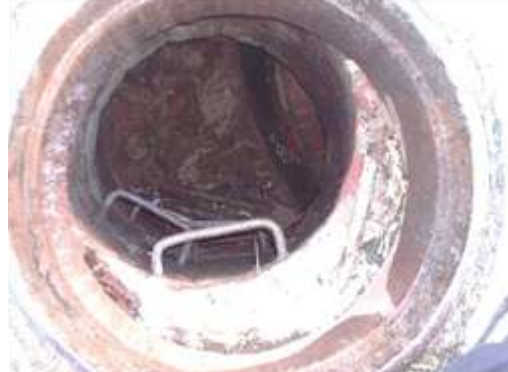
Top View

☒ **Debris** (not Condition related)

☒ **Evidence Of Surcharge**

Evidence of surcharge - Bench debris.

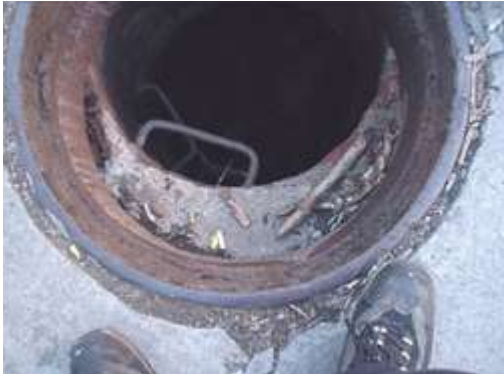
Defect

☒ **Leaks**

Condition: ☐ Sound ☐ Cracked ☐ Root Intrusion ☐ Loose Brick ☒ **Deteriorated**

Infiltration: ☐ None ☒ **Joint** ☐ Cracks ☐ Mortar ☐ Roots ☒ **Wall**

Frame leaks. Frame offset. Adjustment deterioration and infiltration.

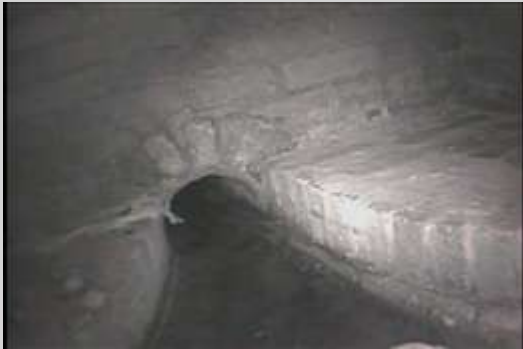
8 in. Circular Gravity Sewer Pipe Out @ 12 O'Clock

Deposits: ☐ None ☒ **Mud** ☐ Sludge ☒ **Debris** ☐ Grease

Silt Depth: **0** (in.) Deposits Extent: **Light**

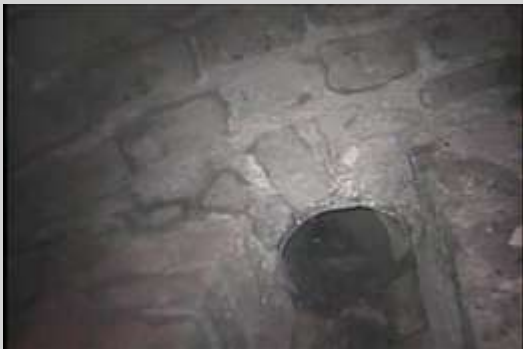
6 in. Circular Gravity Sewer Pipe In @ 5 O'Clock

Deposits: ☐ None ☒ **Mud** ☐ Sludge ☒ **Debris** ☐ Grease

Silt Depth: **0** (in.) Deposits Extent: **Light**

Infiltration: **Evidence** Pipe Seal Cond: **Unknown**

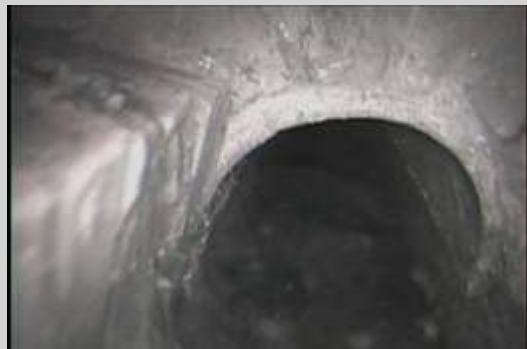
8 in. Circular Gravity Sewer

Deposits: ☐ None ☒ **Mud** ☐ Sludge ☒ **Debris** ☐ Grease

Silt Depth: **0.5** (in.)

Deposits Extent: **Light**
